Arboricultural Impact Assessment

DOC 09

Alaw Môn Solar Farm

October 2023

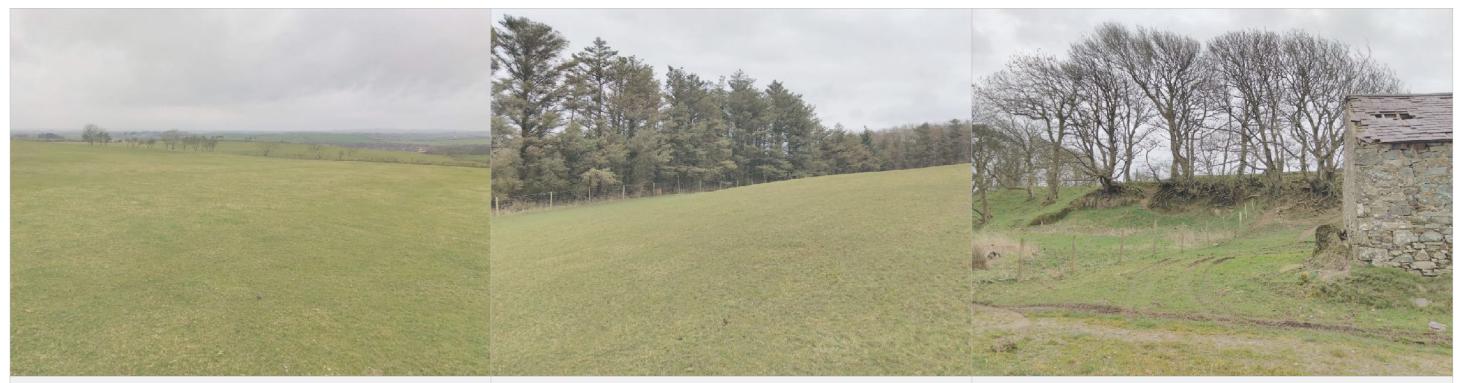
IMAGE 1: Looking west towards G3 (left of centre frame) showing the typical nature of the western part of the Site.

IMAGE 2: Looking south west along the southern edge W2 and W3. W1 can be seen in the background and to the right of centre frame. A 20m buffer is recommended between these woodland belts and any solar infrastructure.

IMAGE 3: Looking south towards the westernmost part of G13.

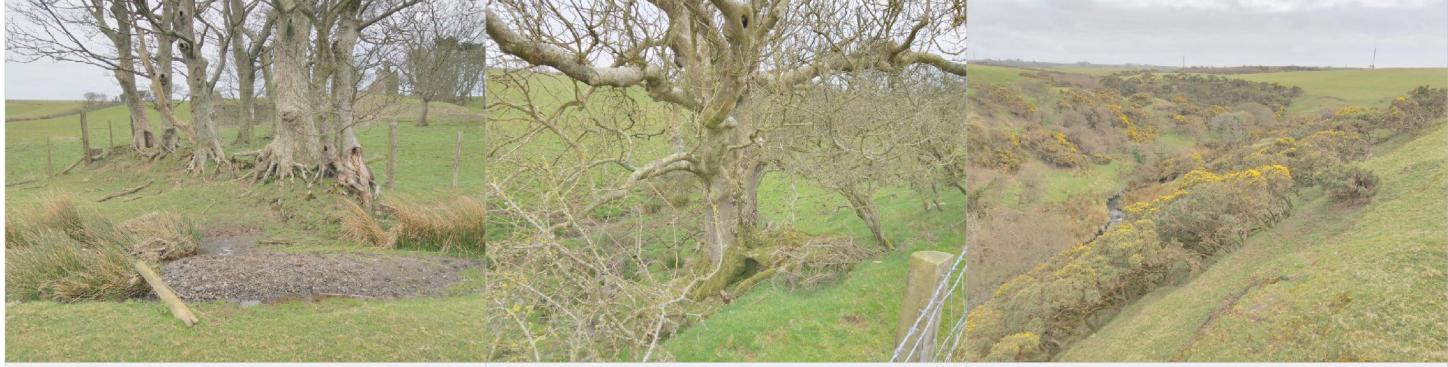
IMAGE 4: Looking north along the western edge of G9 showing the aged and IMAGE 5: Looking east down the slope towards the stem of T6 (a Veteran ash stilted appearance of the trees.

tree). This tree requires an additional buffer to any development.

IMAGE 6:Looking north west along the deep valley of the watercourse that runs through the western part of the Site. The trees in this valley are offSite and comprised of small gorse and hawthorn. These trees were not surveyed.

Т6	Ash	9.0	1	#	990	7-8-11-6	4.0	1.0	N	LM	Veteran	Stunted form with retrenching crown, decay pockets and deadwood throughout crown. Veteran in appearance. Add appropriate Veteran tree buffer.	Good	Fair	20+	А3	11.9	443
Т7	Hawthorn	5.0	7	-	440	5-5-3.5-4	1.0	1.0	Е	М	None	Good form and condition. Characterful twisted trunk.	Good	Good	40+	A 1	5.3	88
Т8	Sycamore	6.0	2	-	350	4.5-4-4-5	3.0	2.5	S	EM	None	Exposed roots on southeast side indicating historic movement. Minor deadwood.	Fair	Fair	20+	B1	4.2	55
Т9	Goat willow	4.0	1	#	300	5-3-4-4	0.5	0.5	W	М	None	Strong trunk lean to west. Good vitality.	Good	Fair	20+	B1	3.6	41
T10	Goat willow	4.0	1	-	280	4-4.5-3-2	1.0	2.5	W	М	None	Basal cavity but good adaptive wood growth.	Good	Fair	20+	B1	3.3	35
T11	Hawthorn	4.0	1	#	180	2.5-2-2	1.0	1	SW	М	None	Isolated tree in area of gorse. Grazing damage on stem.	Fair	Fair	20+	C1	2.2	15
T12	Hawthorn	5.0	1	-	450	5.5-4-1.5-4	1.0	1.5	N	LM	None	Dense crown. Gnarled and twisted old trunk.	Good	Fair	20+	B1	5.4	92

- 4.6. In the absence of any specific guidance for Wales on the incorporation of veteran trees within the Development, the guidance produced for England (in the form of the Forestry Commission and Natural England standing advice) has been applied in this case. A key method of mitigating impacts upon Veteran trees is the use of a 'buffer zone'. Therefore, in applying the standing advice for England an additional veteran tree buffer has been assigned to T6.
